Voltage Dip Ride Through Testing for Dynamically Positioned Vessels

OneStep Power Solutions Inc.
Jan 2020

Repeatable and Safe Voltage Dip Ride Through Testing for Dynamically Positioned Vessels.

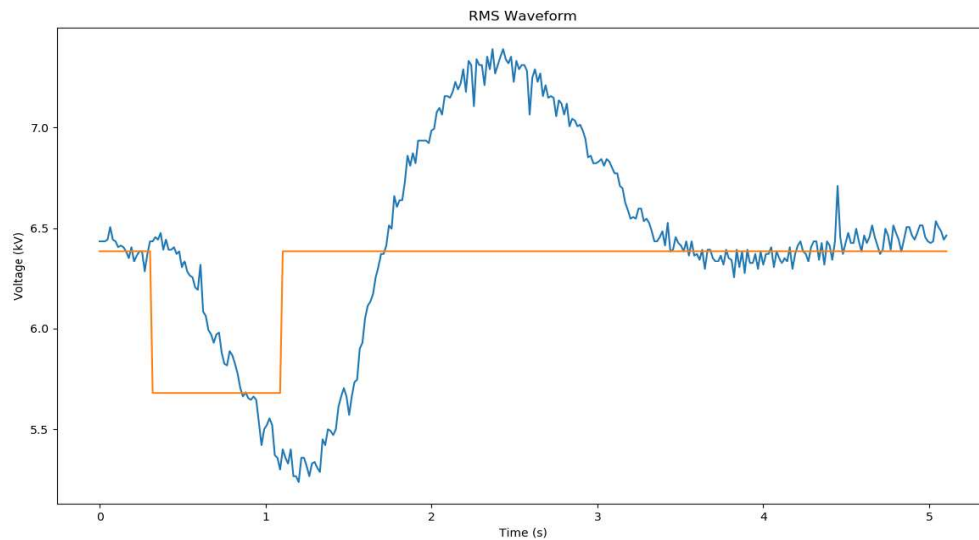
Figure 4. RMS of Test-03 800 ms single 10.8 MVA generator

The result of the 800 ms test shown in figure 4 was an overvoltage alarm on the power management system (PMS), no equipment was lost and the ship remained in DP with no loss of position. On calculation, the overvoltage peaked at approximately 118%.

These test results demonstrated that the longer the field is held low, the greater the voltage drop and subsequent voltage overshoot experienced. Very similar curves were observed with the unloaded tests conducted on the 5.3 MVA generators.

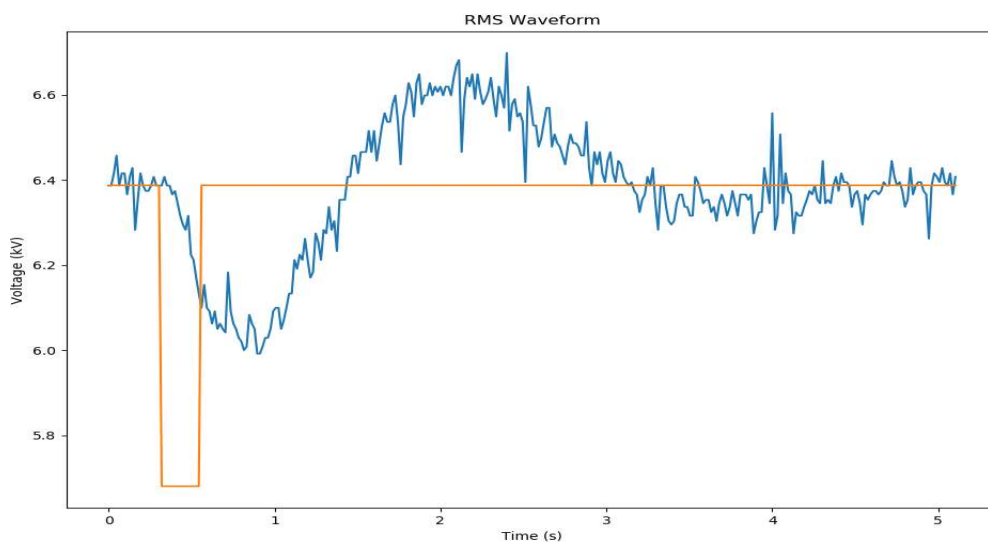
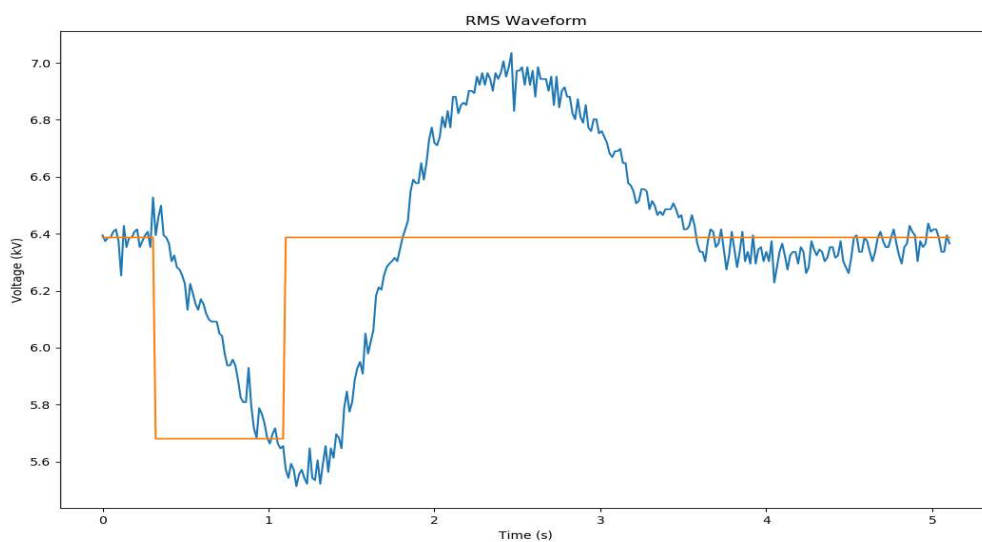
As can be seen in figures 5, 6, 7 and 8, the bus voltage reacted with similar curves though the voltage dips and transient overvoltages were not as extreme.

Figure 5. RMS of Test-04 250 ms closed bus

Figure 6. RMS of Test-05 500 ms closed bus

Figure 7. RMS of Test-06 800ms closed bus

Figure 8. RMS of Test-07 850 ms closed bus

Figures 2 through 8 clearly demonstrate the ability to induce voltage disturbances on the power system using the method of interrupting the field current of a generator. The intent of the testing was not to drive the voltage of the system to zero, the voltage dip experienced was not considered enough to verify an extreme voltage deviation as would be experienced when a low impedance short circuit occurs. The transient overvoltage directly following the voltage dip was considered similar to what would be experienced as part of a short circuit. As fast breaker switching was already used to test for extremely low voltage transients the key outcome for this testing was the overvoltage reaction.

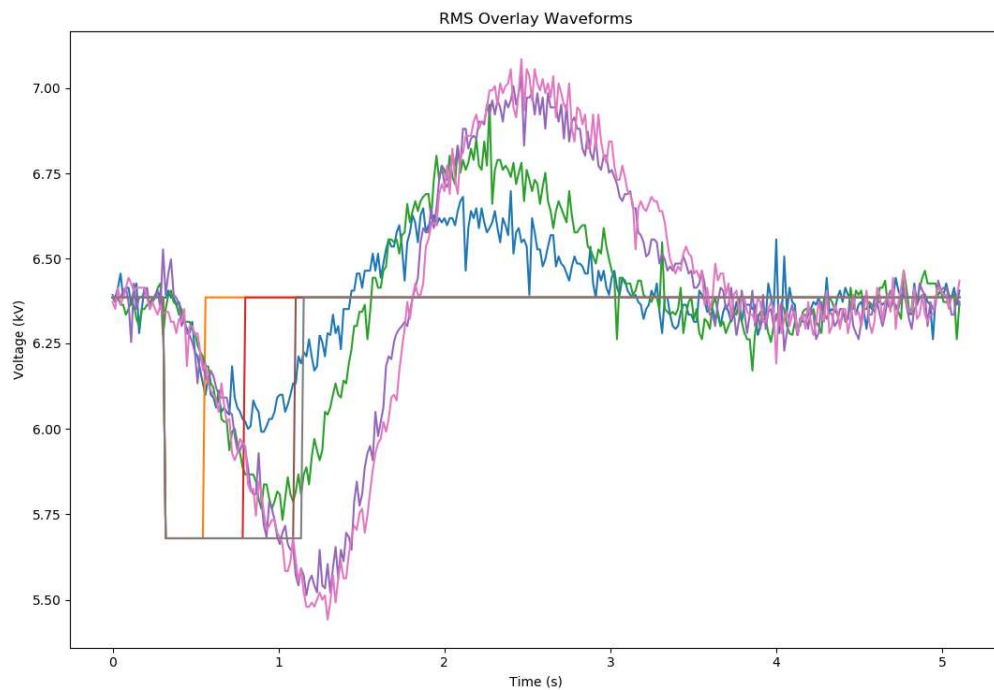
Figure 9. RMS of Tests 04 to 07 (closed bus testing)

To give a better overview of the progression of the testing, the following graph of the closed bus responses was developed. This graph, figure 9, demonstrated the slopes of the decay and growth of the electrical potential on the bus. There was a non-linear decay when extrapolated that illustrated the relationship between the duration of the removal of the field current and the extent of the voltage dip and over-voltage.

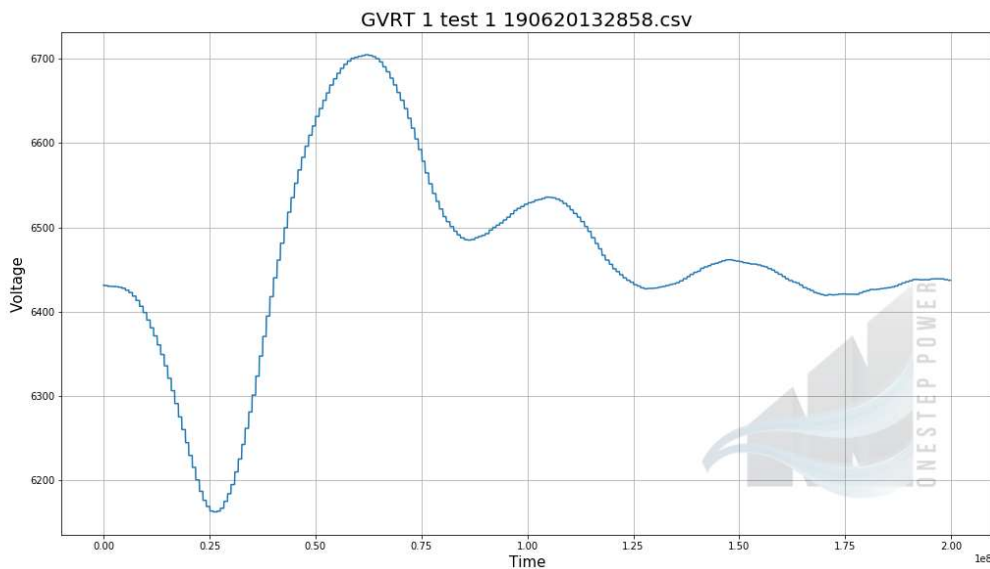
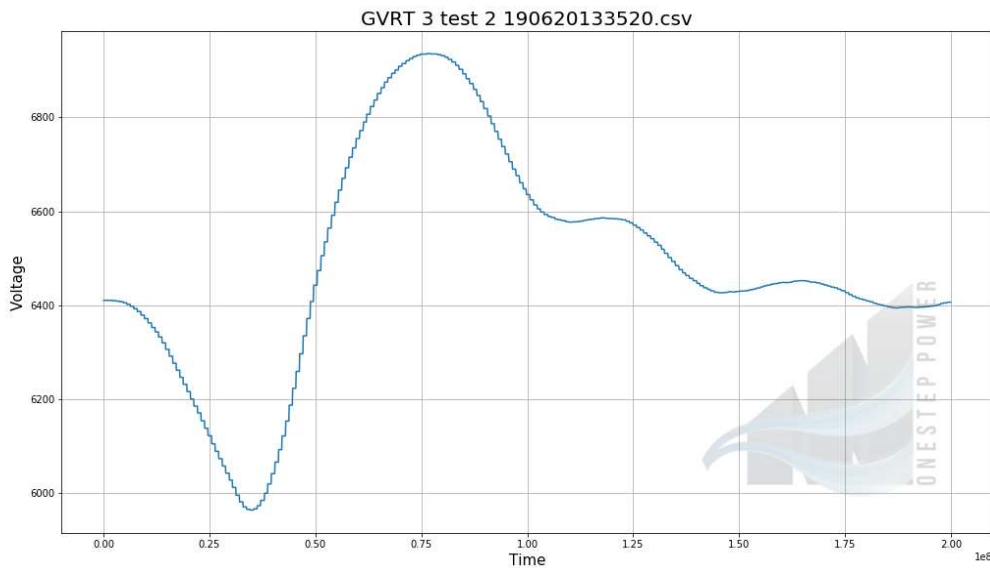
Initially two of the 5.3 MVA units were tested with the generator disconnected from the bus which resulted in an unstable response. As the new AVR had the ability to be set with multiple tuning parameters for operation online and offline, further testing was conducted with a single generator online. As can be seen in figures 10, 11, 12 and 13 the system voltage had a substantial overshoot when compared to the tests of the same time period on the sister vessel. The test that is shown in figure 13 resulted in an overvoltage alarm being generated on the power management system.

Figure 10. Test-01 (GVRT-1, DG-2) Results

Figure 11. Test-01 (GVRT-3, DG-4) Results

Figure 12. Test-02 (GVRT-1, DG-2) Results

Figure 13. Test-02 (GVRT-3, DG-4) Results

These graphs indicate the generator AVRs had an underdamped response that may not have settled to the required 3% within 1.5 seconds, as per ABS⁷ and DNV⁸.

No further testing was conducted on this vessel and the vessel owner arranged for the AVR installer to return and re-tune the AVRs prior to commencing operations.

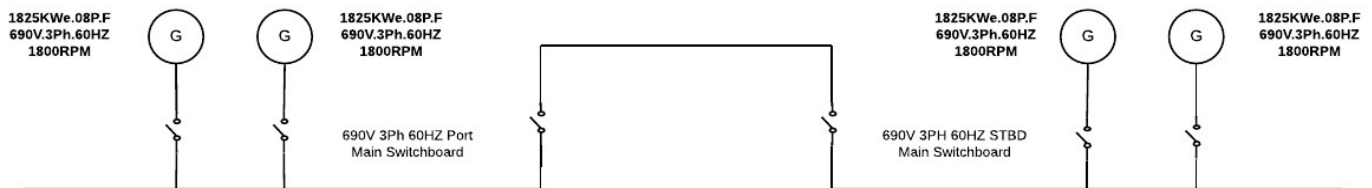
Figure 14. Power system of vessel 3

After discussions with and requests from industry it was decided to design and incorporate a method of forcing the bus voltage to zero for a controlled time. OneStep Power's ZeroDip was designed to provide an integrated solution for high-speed breaker switching during the transients induced by the GVRT. The third vessel discussed had two buses with four 1.8 MW 690 V generators, two generators on each bus, as shown in figure 14.

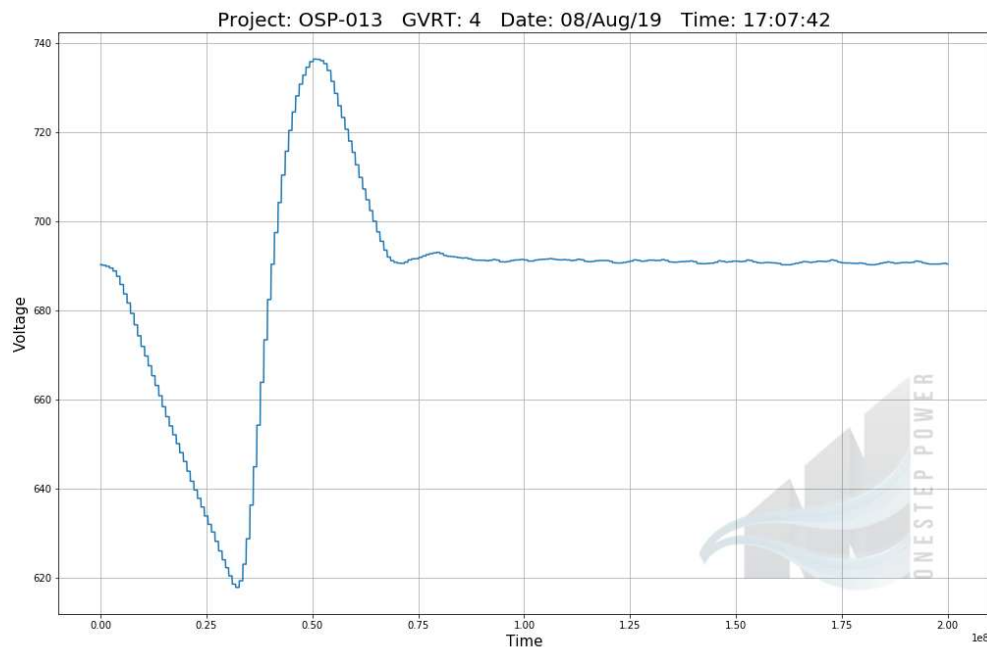
Figure 15. Waveform of Test-01

Due to operational requirements the vessel under test was in port and not able to run the thrusters under load. A number of tests to verify generator operation were conducted. All generators had a similar response as shown in figure 15. The vessel failed the initial ZeroDip testing and the combined testing of zero dip and voltage transients was not conducted as no benefit could be gained.

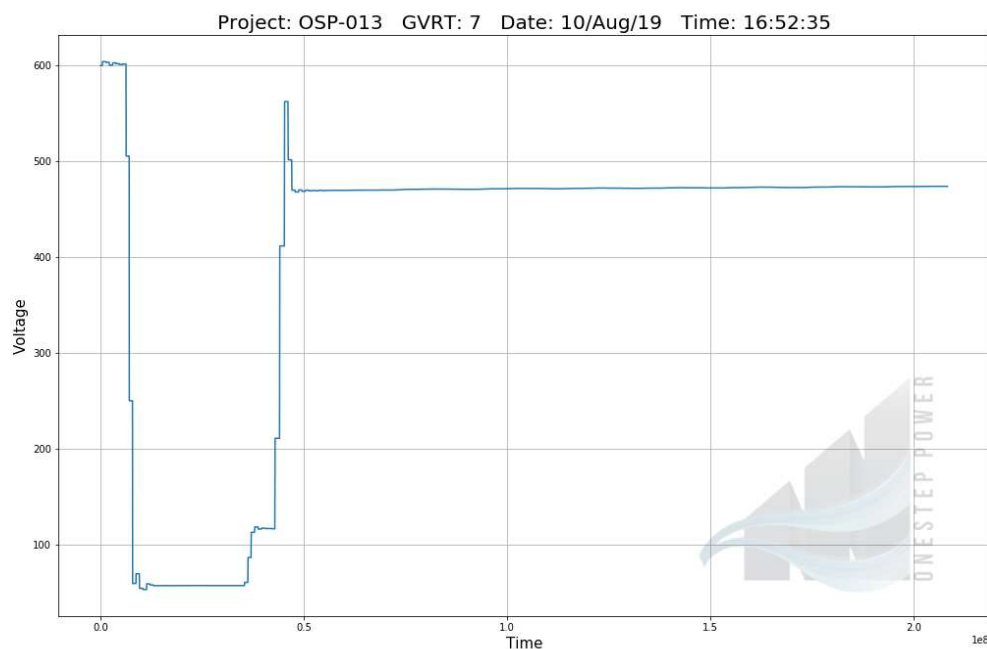
Figure 16. Waveform of Test-02

In order to prove a system's ability to ride through the voltage dip that would be experienced by the consumers during a three-phase symmetrical short circuit, the test duration was required to be greater than the bus tie circuit breaker trip times. The vessel under test had bus tie breakers set for 300ms. To be sure to account for possible delays a test time of 350 ms was selected for the test. In Figure 16 the bus voltage collapsed to zero and was reinstated approximately 350 ms later. While the voltage was restored to the 690 V bus, all 480 V, 208 V, thrusters and DP equipment was lost.

Note: the discrepancy in the voltage after re-application of the power was due to the open delta transformers being unevenly loaded caused by the loss of equipment after the voltage interruption.

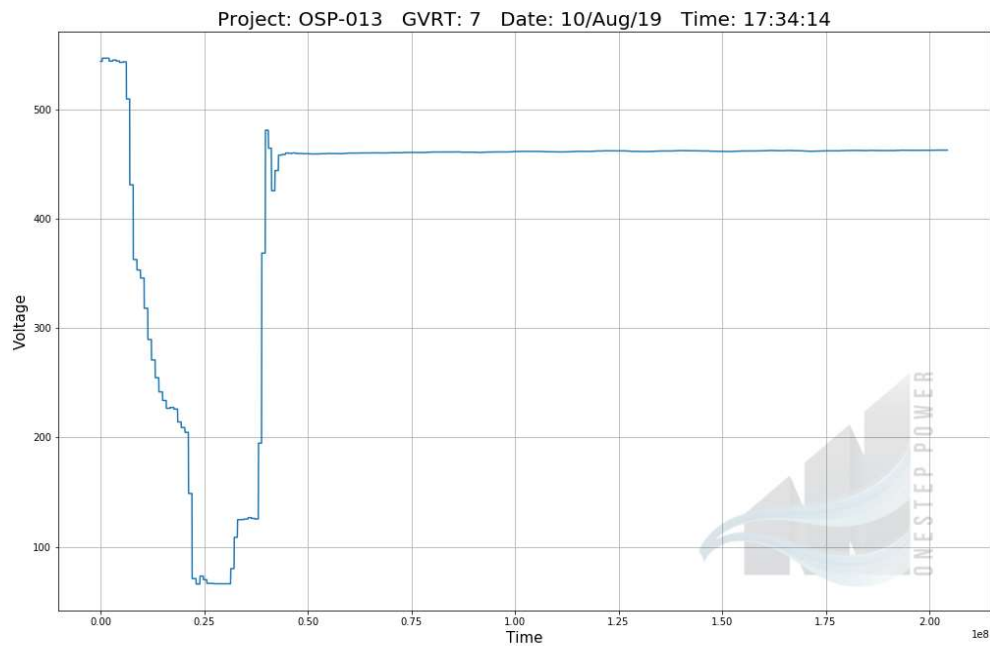
Figure 17. Waveform of Test-03

As the vessel failed a 350 ms test, the time was reduced to 310 ms to ascertain if the system would ride through a loss of voltage for 300 ms. The test of 310 ms, shown in figure 17, also failed with the loss of all 480 V, 208 V, thrusters and DP equipment.

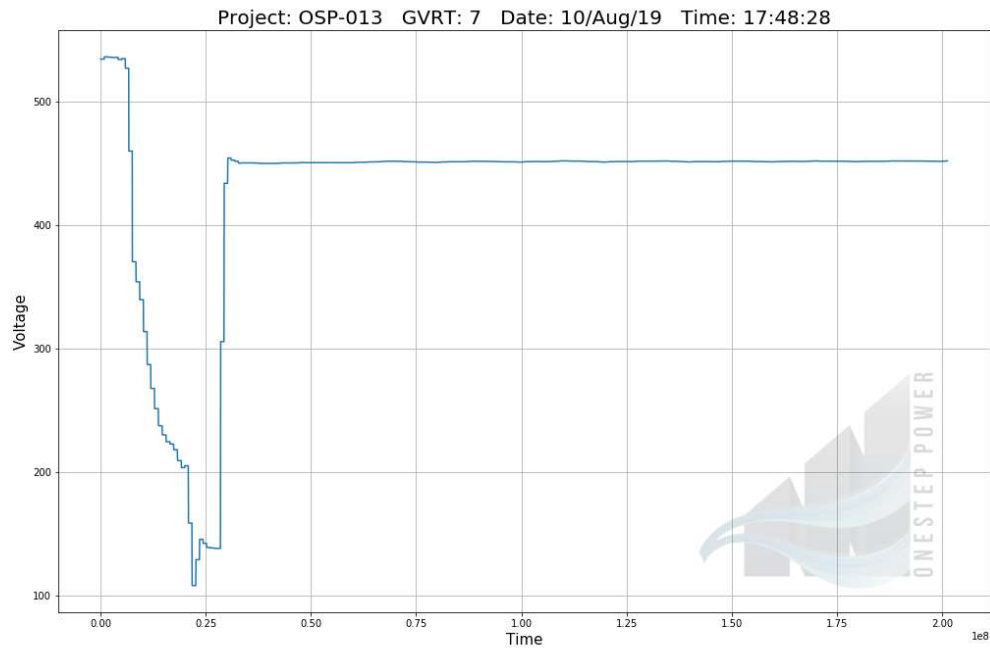
Figure 18. Waveform of Test-04

To verify the system response the test time was reduced to 200 ms. This test is shown in figure 18. Again all equipment from the 480 V bus and down was lost.

Further testing was halted as a combination of voltage dip followed by transient overvoltage would result in a failed test and no further useful information would be gained.

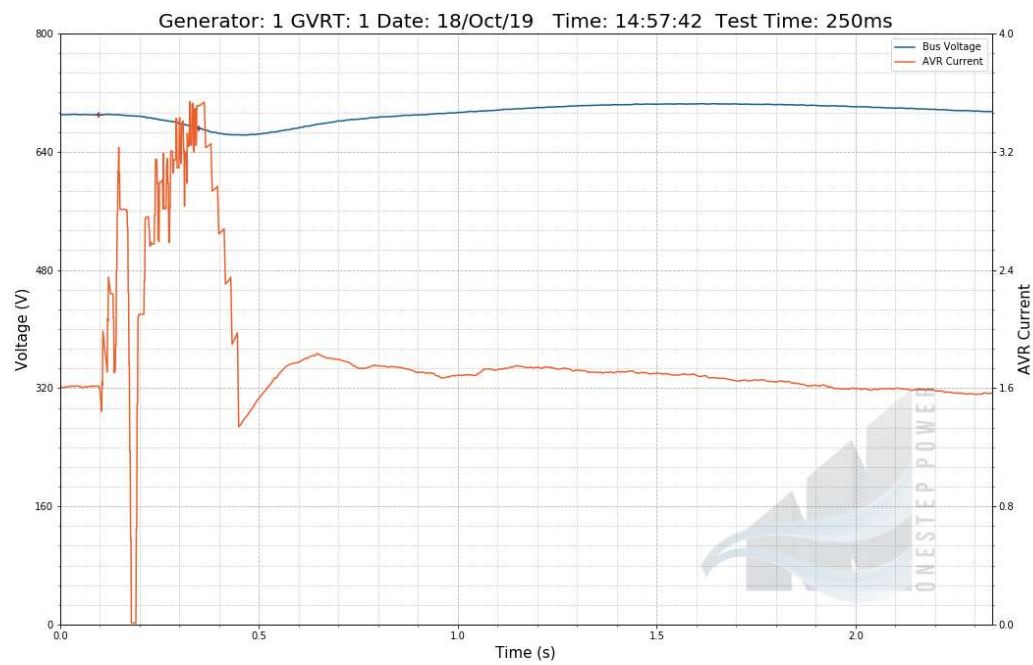
All generators were tested disconnected from the bus and were found to have good responses and no instability. Once the generator responses had been verified as acceptable, each generator was connected to the bus individually with bus ties open and tests conducted to confirm system and consumer responses on each bus. The first test was conducted for 250 ms and the result shown in figure 20. All generators and buses demonstrated similar responses with no loss of DP equipment.

Figure 20. Results of Test 01, Generator #1 250 ms open bus

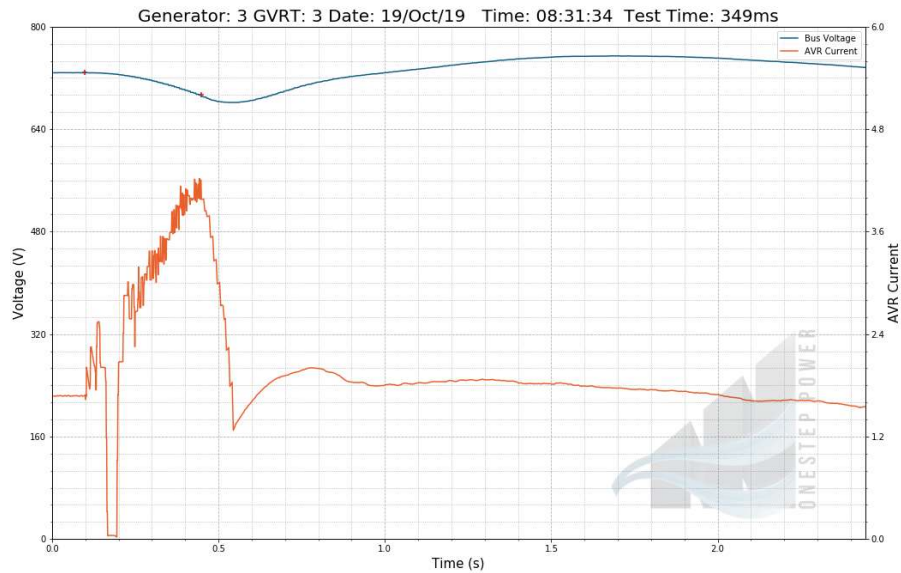
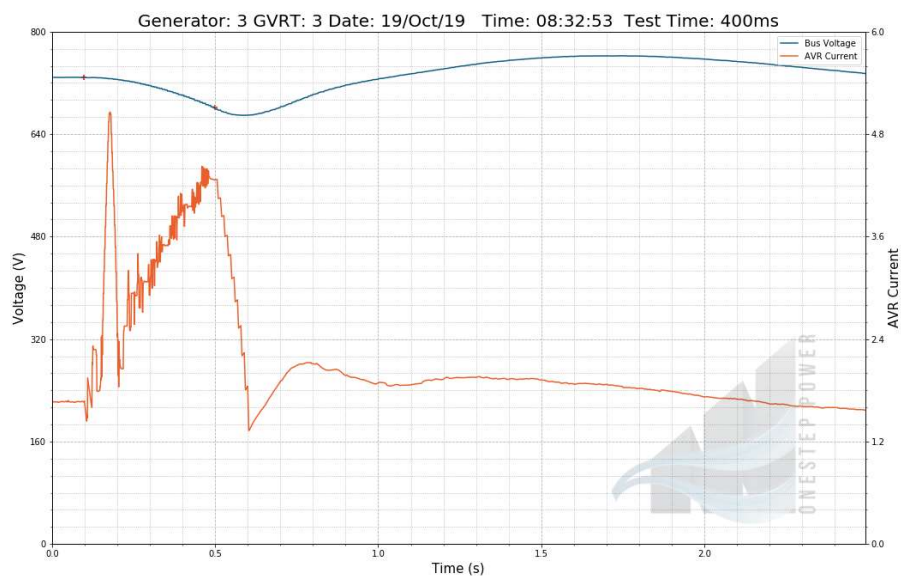
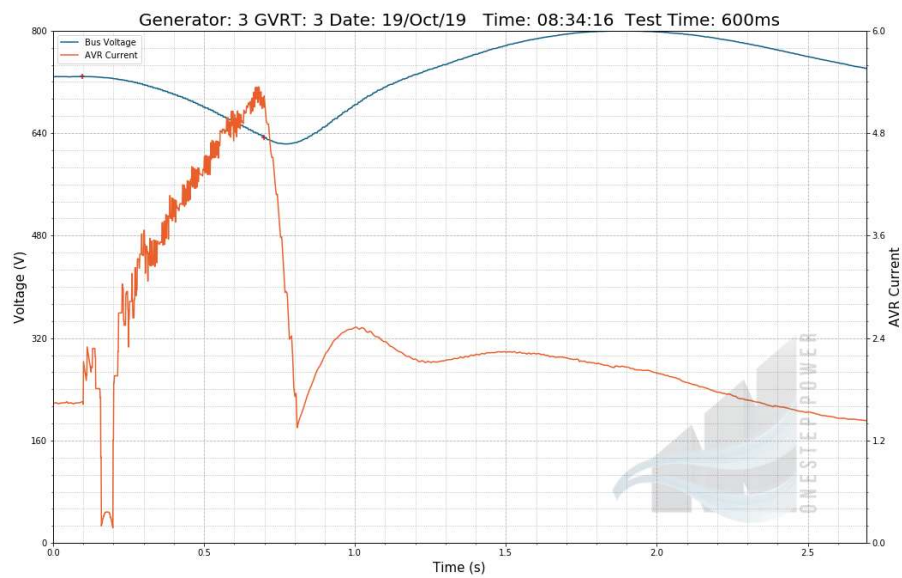
The next set of testing was conducted with all generators online and an increased system load. The thrusters were placed in bias mode and the system power increased. A 350 ms test was conducted on all three generators with the resulting response shown in figure 22. As this was a common bus all generators had the same response and no vessel equipment was lost during this test. To increase the severity of the voltage dip and subsequent overvoltage, the test time was increased to 400 and 600 ms with results shown in figures 23 and 24.

Figure 22. Results of Test 02, Generator #3: 350ms

Figure 23. Results of Test 02, Generator #3: 400ms

Figure 24. Results of Test 02, Generator #3: 600ms

Again it was noted that all generators had the same responses and no equipment was lost, however there was a low voltage alarm on the thruster control panels during the 600 ms test.

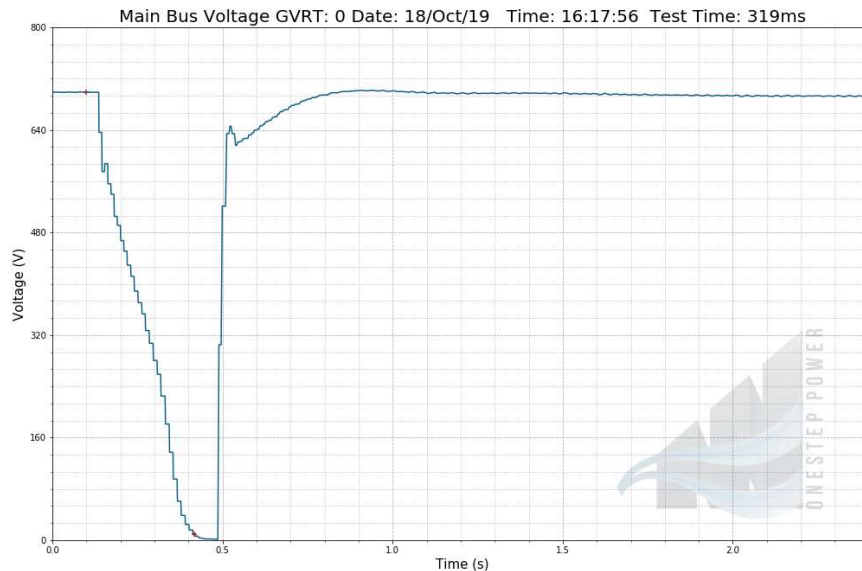
Figure 25. Results of Zero Volts, Bus B: 320ms

Testing for a zero volts dip without a transient overvoltage component was conducted following the GVRT testing. All systems passed this test. Figure 25, shows the response on Bus B of a 320 ms test. All other zero dip testing resulted with similar graphs and nothing would be gained by their addition.

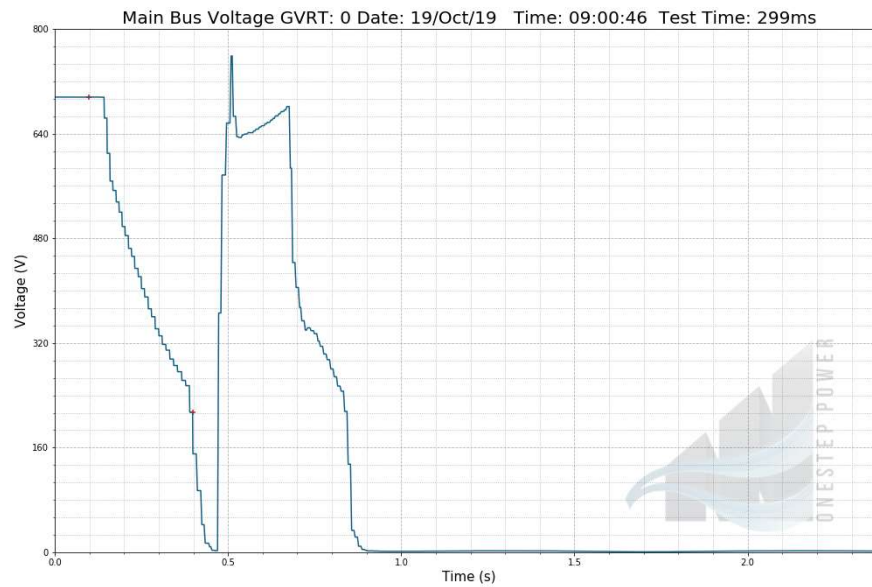
The first combined test of zero dip and transient voltage testing resulted in section protection operating and opening all bus tie breakers, thus leading to blackout on the section under test. This blackout is not a failure as the open bus ties left the adjacent section live, in the event of an actual short circuit this is the response that would be expected. This event demonstrated the efficacy of the voltage dip ride through testing.

Figure 26. Results of Test 04, Bus B: Fail (Segment protection tripped bus tie)

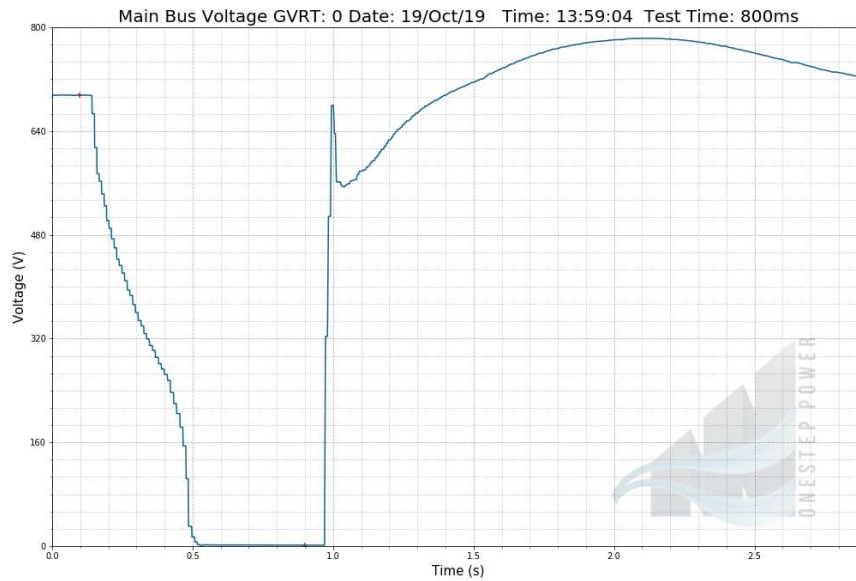
Figure 34. Results of Test 12, Bus A: Pass (800ms)

The final test conducted aboard the vessel, shown in figure 34, was conducted on the system with two generators online on Bus A with all thrusters and DP systems online. The voltage dropped to zero prior to the system inducing an overvoltage of $\approx 115\%$.

No equipment was lost during this test indicating that DP system and all auxiliary systems are capable of riding through both the undervoltage and overvoltage that would be experienced by a power system during a short circuit.
